Inspection Report for Mr. Jason Smith

Property Address: 124 13rd St NE, Seattle, Washington 98052

NW WASHINGTON HOME INSPECTIONS LLC

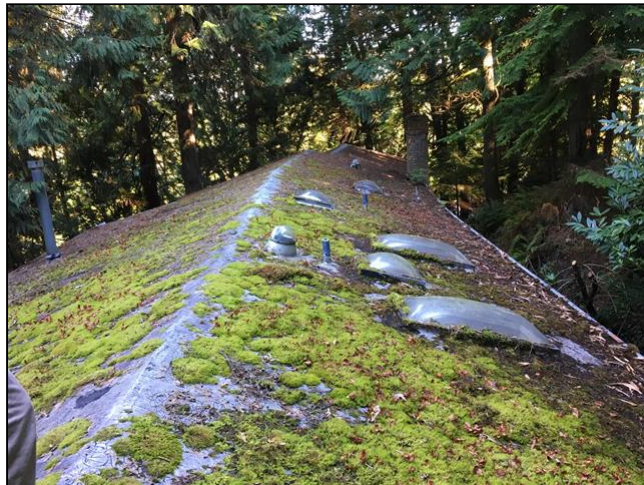
(1) The roof is heavily covered in moss and is showing signs of significant deterioration where visible. Recommend the roof be professionally cleaned and further evaluated for repair and/or replacement by a certified roofing contractor.

⚠ (1) The roof is heavily covered in moss and is showing signs of significant deterioration where visible. Recommend the roof be professionally cleaned and further evaluated for repair and/or replacement by a certified roofing contractor.

1.0 (1) Heavy Moss on Roof

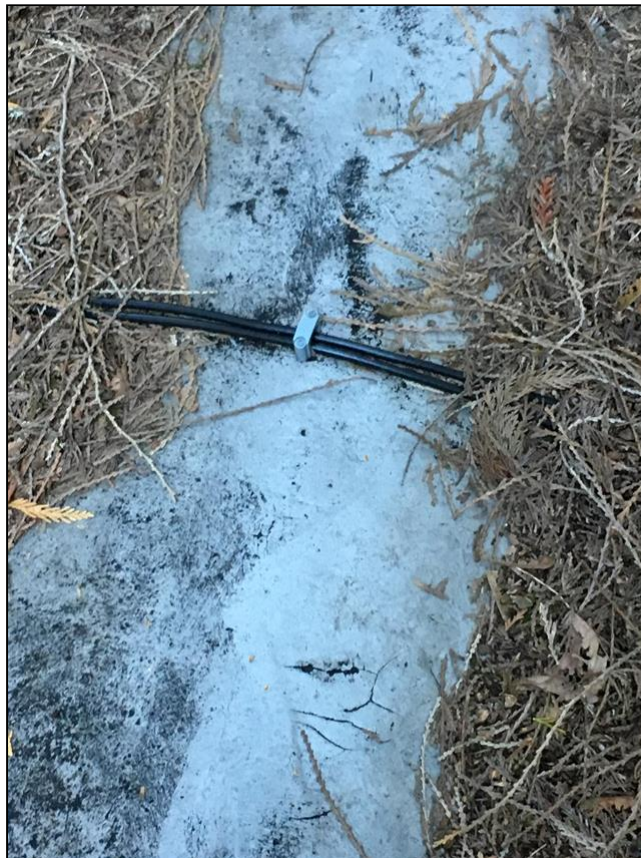
1.0 (2)

(2) Mechanical fasteners (nails) have been used to secure cable television wires and have penetrated the roof membrane. This may compromise the watertight integrity of the roof. The fastener should be caulked or sealed in place. Alternately, the cable wires should be re-routed so as not to transverse the roof and the residual holes sealed.

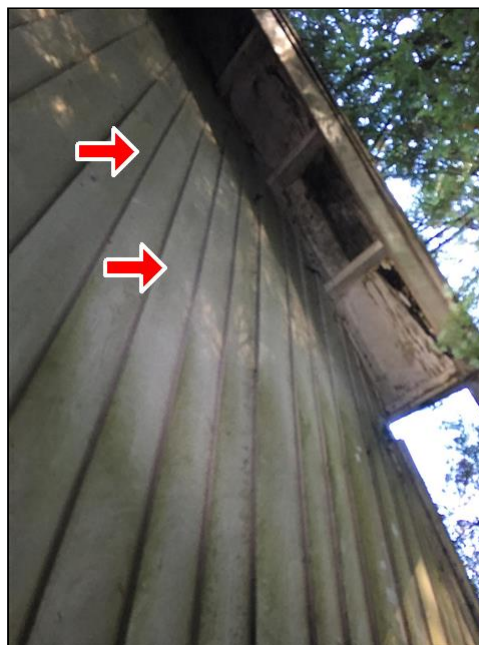
1.0 (3)

(3) The roof plywood sheathing visible through the open soffits on the NW corner of the house is visibly damaged. Further inspection by a roofing contractor is recommended.

⚠️ (3) The roof plywood sheathing visible through the open soffits on the NW corner of the house is visibly damaged. Further inspection by a roofing contractor is recommended.

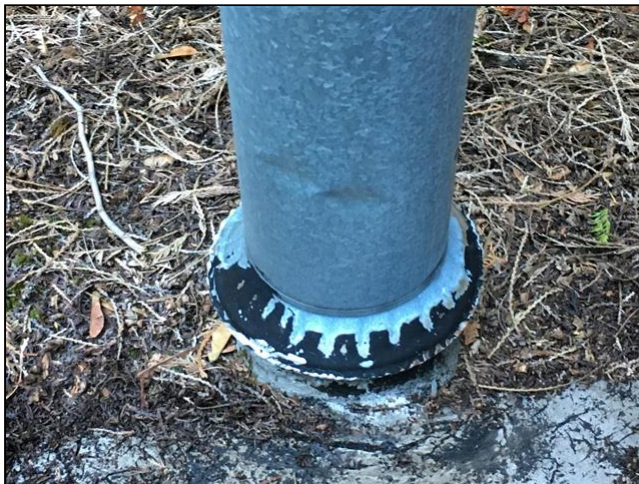
(1) The flashing around the vent is in poor condition and appears to have been repaired in the past. This is consistent with the overall condition of the roof.

1.2 (1) Repaired Flashing

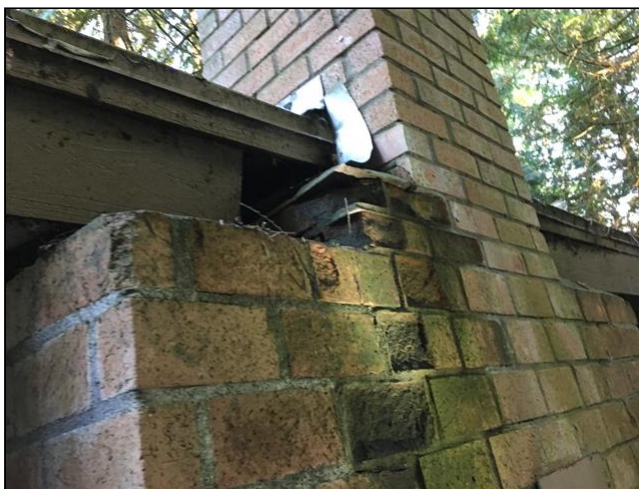
1.2 (2)

(2) The flashing at the brick chimney is improperly installed. Excessive moisture has resulted in visible moisture damage of the soffit and bricks. Recommend repair by a licensed contractor.

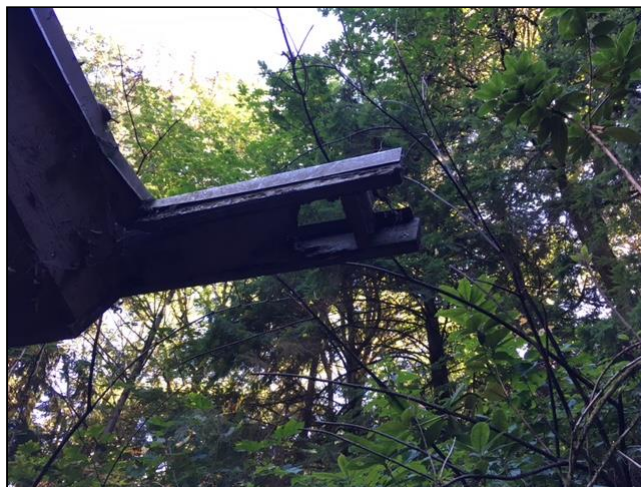
(1) The gutters are integrated into the roof and are made of cedar. The gutters are heavily deteriorated and require repair and/or replacement. Please consult a licensed roofing contractor as he/she may be able to offer several options for repair/replacement.

The rotting wood represents conditions conducive to wood destroying organism. Removal and replacement of the failed gutters will eliminate the risk.

1.3 (1) Failed Cedar Gutters

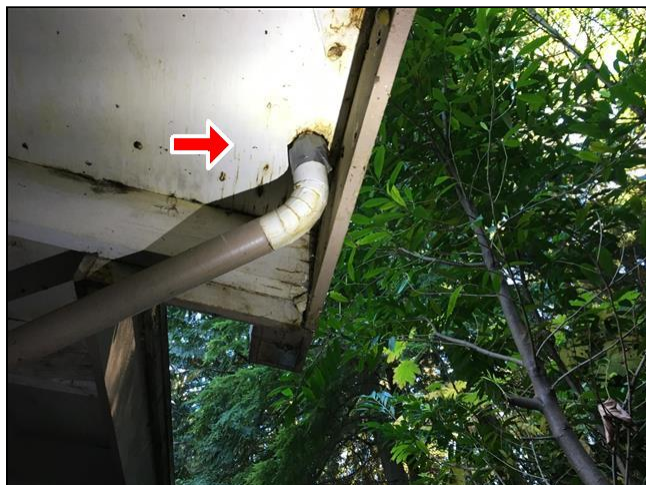
(2) One or more downspouts designed to discharge roof drainage was damaged or in disrepair to an extent that may limit its ability to function as designed. This condition can result in excessively high moisture levels in soil at the foundation and can cause damage related to soil/foundation movement. Excessive moisture levels in soil near the foundation can effect the ability of the soil to support the weight of the structure above and can cause damage related to soil/foundation movement. The Inspector recommends repair to help protect the home structure. All work should be performed by a qualified contractor.

1.3 (2) Failing Gutters

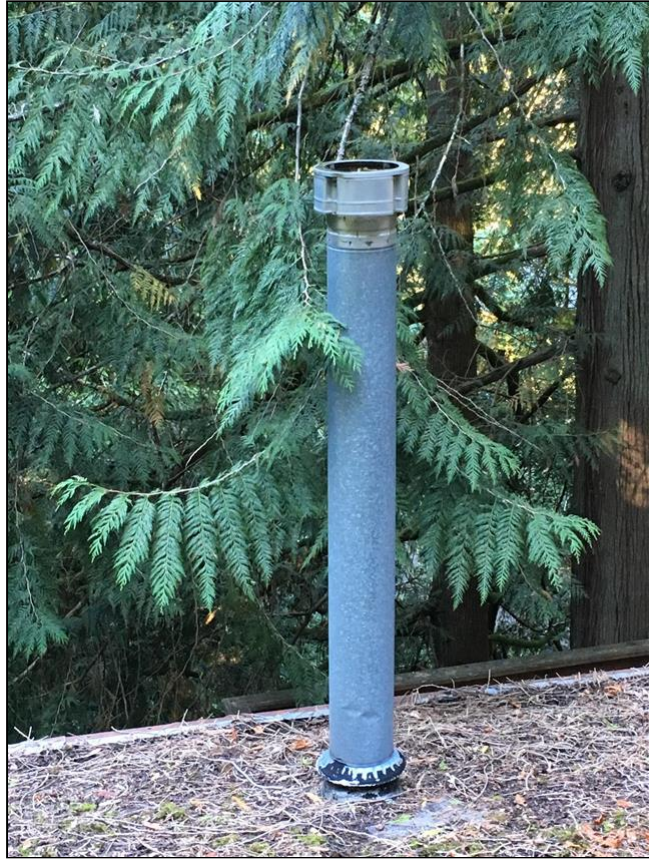
Tree limbs should be trimmed back so as not to contact the roof or hot water heater vent. This can cause roof damage and pose as a fire hazard.

1.4 (1) Tree branch interference

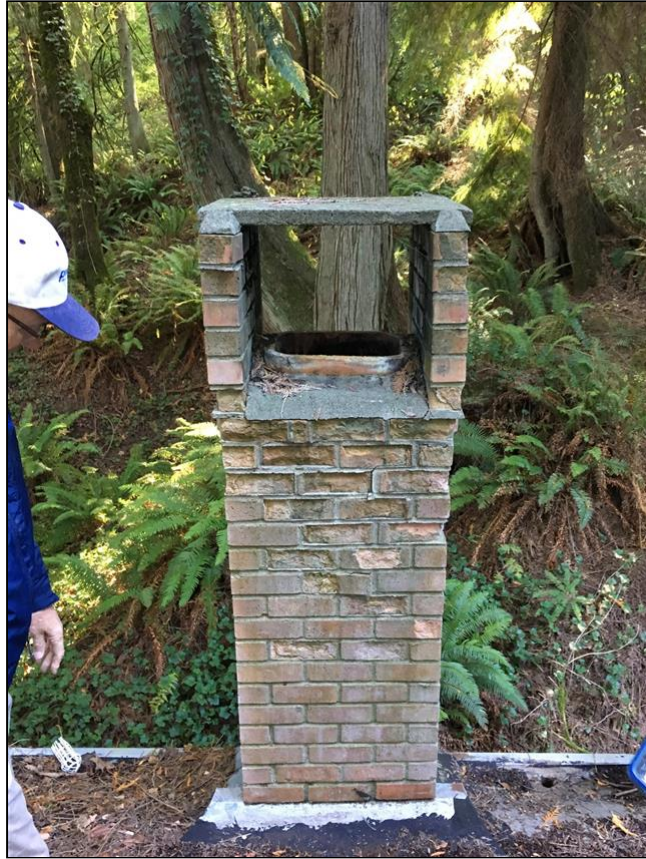
The brick chimney exhibited brick spalling, crumbling, or delamination of the brick face. This is typically caused by a combination of moisture absorption and improper mortar mix design. This deterioration will probably continue unless the problem is identified and corrected. The inspector recommends that an evaluation and any necessary work be performed by a qualified masonry contractor.

1.5 (1) Chimney at the roofline

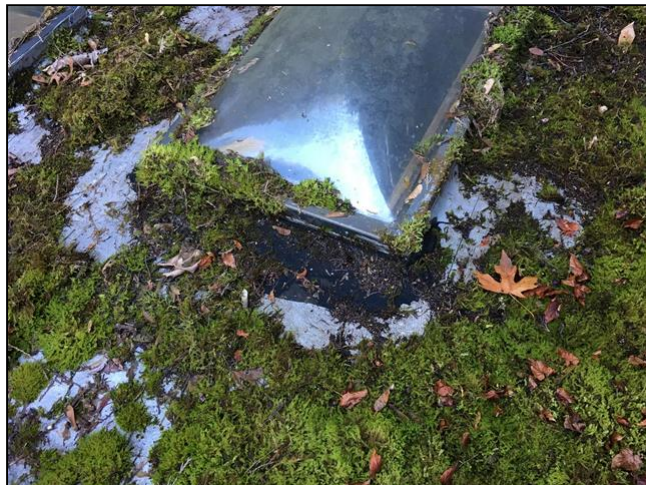
The areas at which the skylights penetrated the roof were protected by sealant instead of metal flashing. Sealants have a much shorter lifespan than metal flashing and will eventually dry, shrink and crack, providing a point of entry for moisture intrusion of the roof structure and increased chances of leakage. This sealant should be checked annually and re-applied as necessary. The Inspector recommends installation of properly-installed skylight flashing.

1.6 (1) Skylights - no flashing

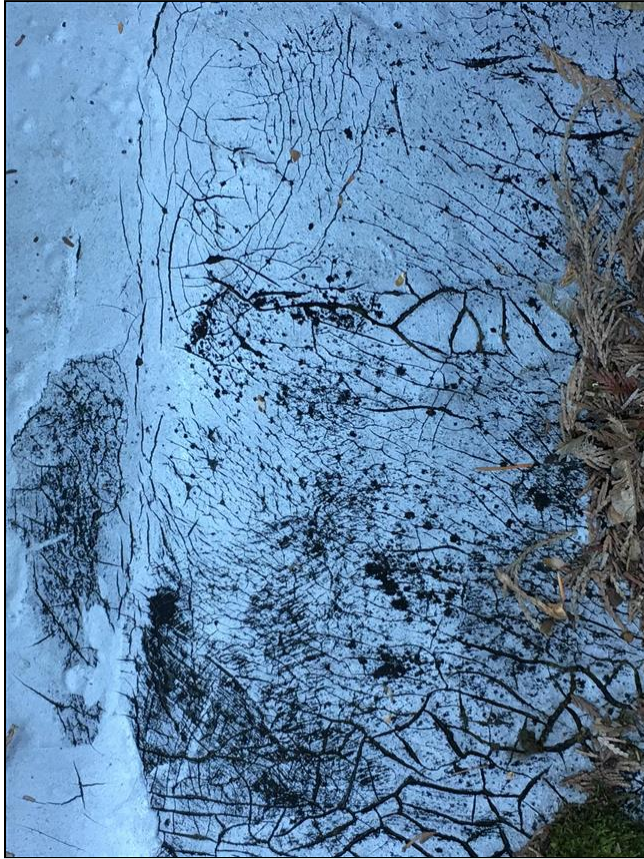
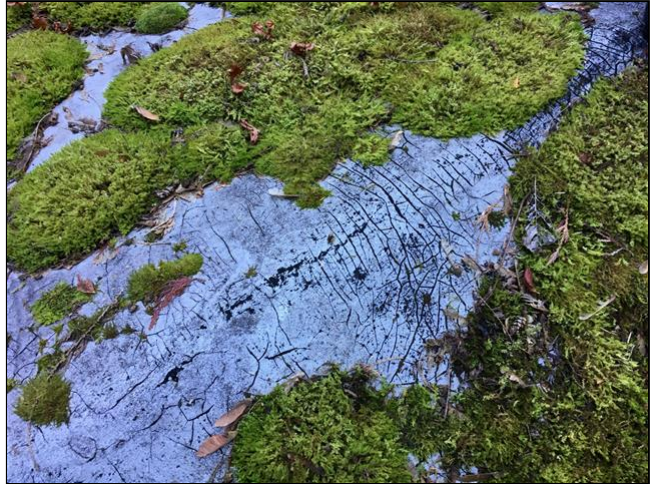
At the time of the inspection the built-up roofing membrane had widespread cracking visible. This condition may increase the chance of leakage with the potential for roof structure damage from wood decay, damage to home materials, or the development of microbial growth such as mold. The Inspector recommends that before the expiration of your Inspection Objection Deadline, you consult with a qualified roofing contractor to discuss options and costs for repair or replacement.

that before the expiration of your Inspection Objection Deadline, you consult with a qualified roofing contractor to discuss options and costs for repair or replacement.

1.7 (1) Roof Cracking

1.7 (2) Heavy Roof Cracking

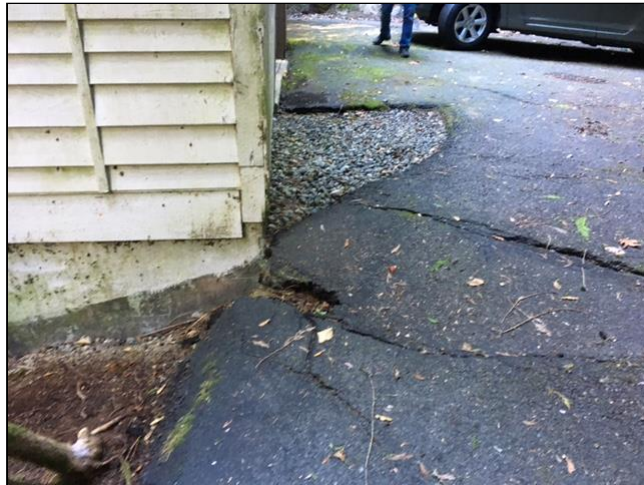
Significant cracks visible in the driveway at the time of the inspection should be filled with an appropriate sealant to avoid continued damage to the driveway surface from freezing moisture.

3.1 (1) Deteriorating Asphalt Driveway

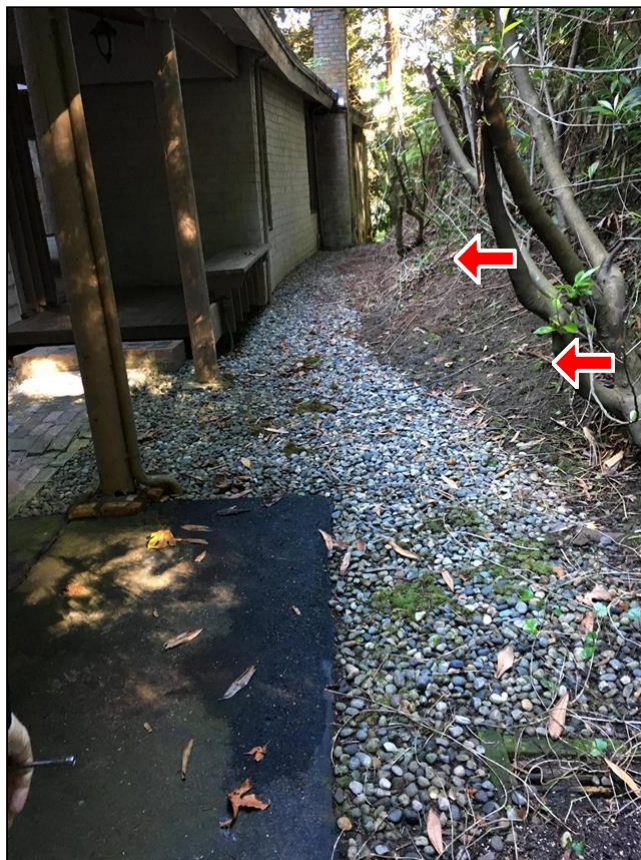
3.3 (1)

(1) The home was built on a hillside that will drain runoff from precipitation toward the home foundation. This condition can result in soil supporting the home foundation becoming saturated. Saturation of soil supporting the foundation can cause structural problems. The Inspector recommends that before the expiration of your Inspection Objection Deadline you consult with a qualified contractor to discuss options and costs for action that will help protect the home foundation.

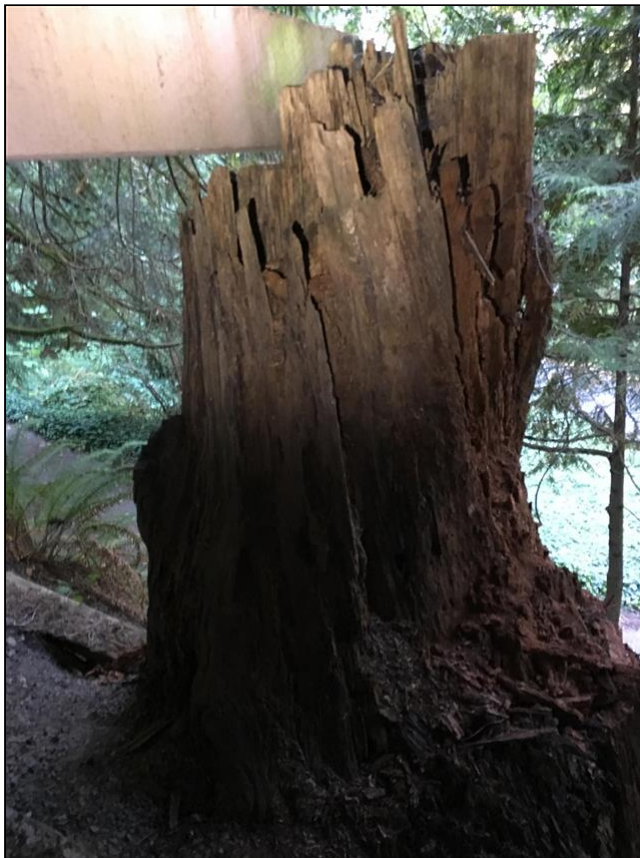
3.3 (2)

(2) A dead tree stump in close proximity to the deck and house poses a risk for wood destroying organisms that could be introduced to the house structure. Recommend removing or cutting back the tree stump.

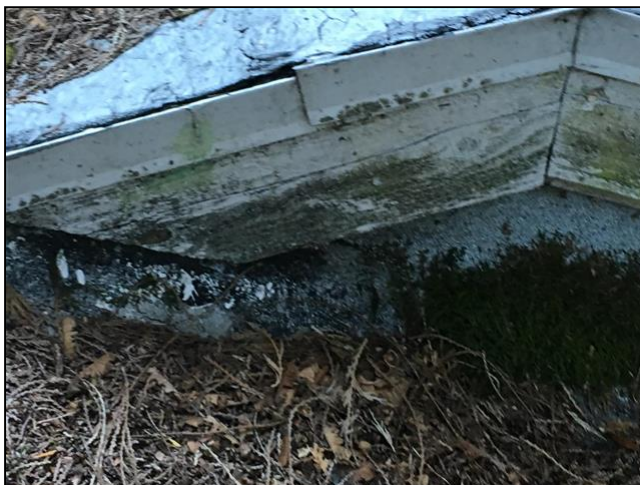
3.4 (1)

(1) At the time of the inspection, the fascia on the upper roof exhibited moderate general deterioration and water damage. Recommend repair and replacement by a licensed contractor.

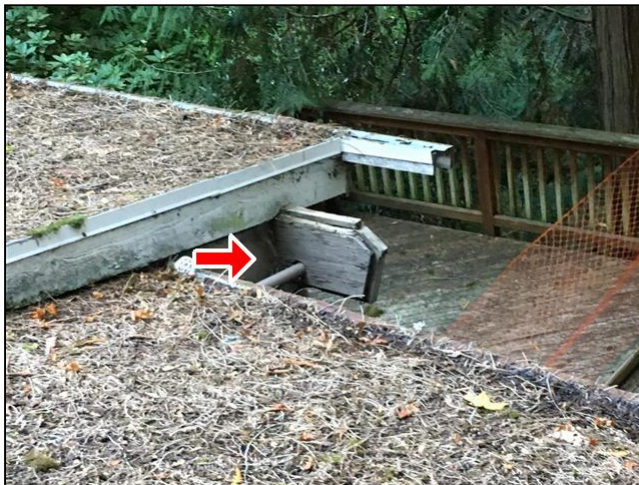
3.4 (2)

(2) The exposed exterior wooden support beams are in need of staining/ preservation to prevent further deterioration.

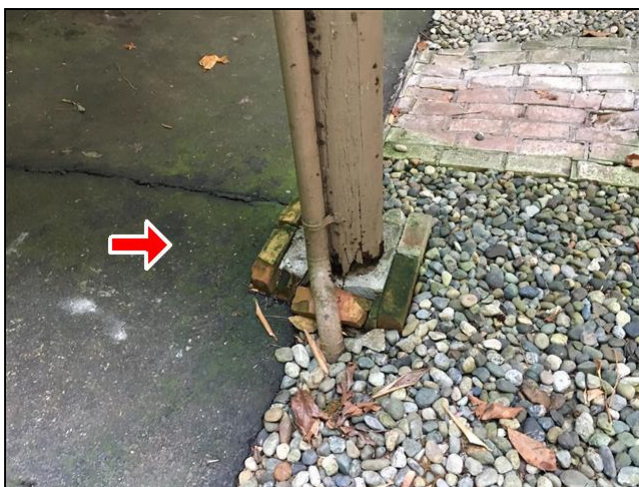
3.6 (1)

(1) This support post leading to the front entrance is decaying at the foot of the post. The post should be repaired or replaced by a licensed contractor.

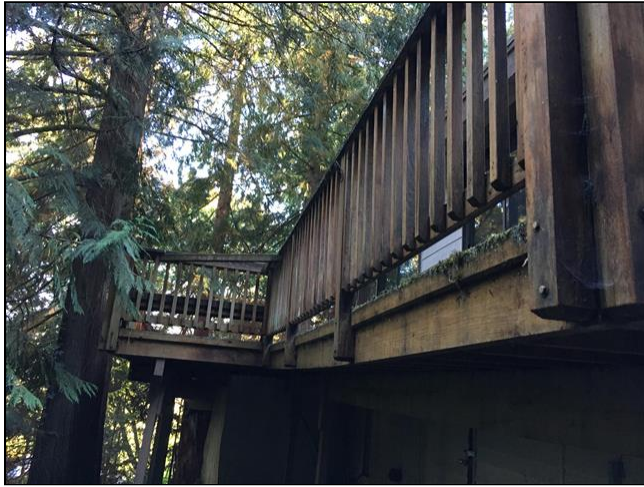
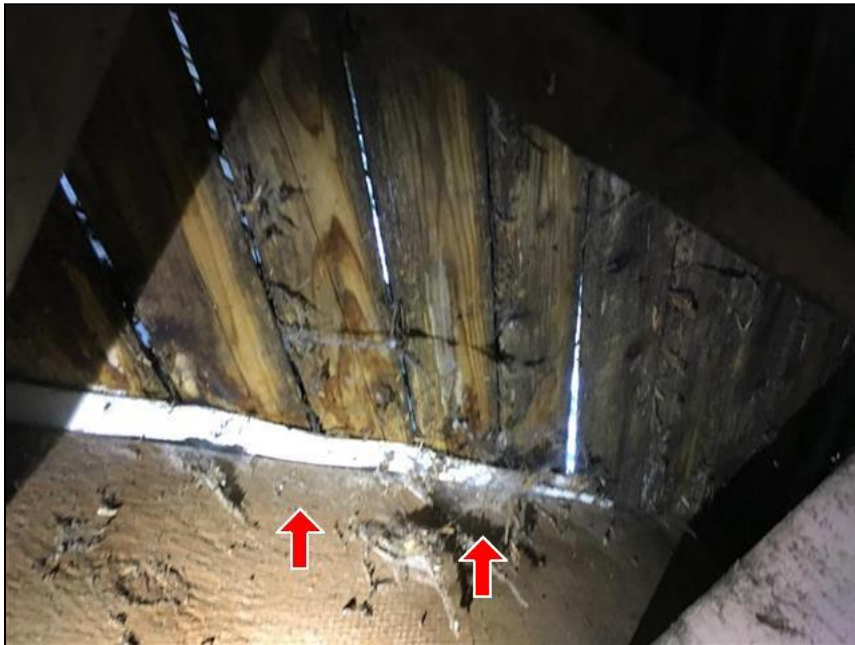
(2) At the time of the inspection, the deck exhibited severe deterioration. The Inspector recommends that before the expiration of your Inspection Objection Deadline you consult with a qualified contractor to gain an idea of options and costs for repair or replacement.

⚠ (2) At the time of the inspection, the deck exhibited severe deterioration. The Inspector recommends that before the expiration of your Inspection Objection Deadline you consult with a qualified contractor to gain an idea of options and costs for repair or replacement.

3.6 (2) Old Wrap Around Deck - Back

3.6 (3) Rotten Decking from Below

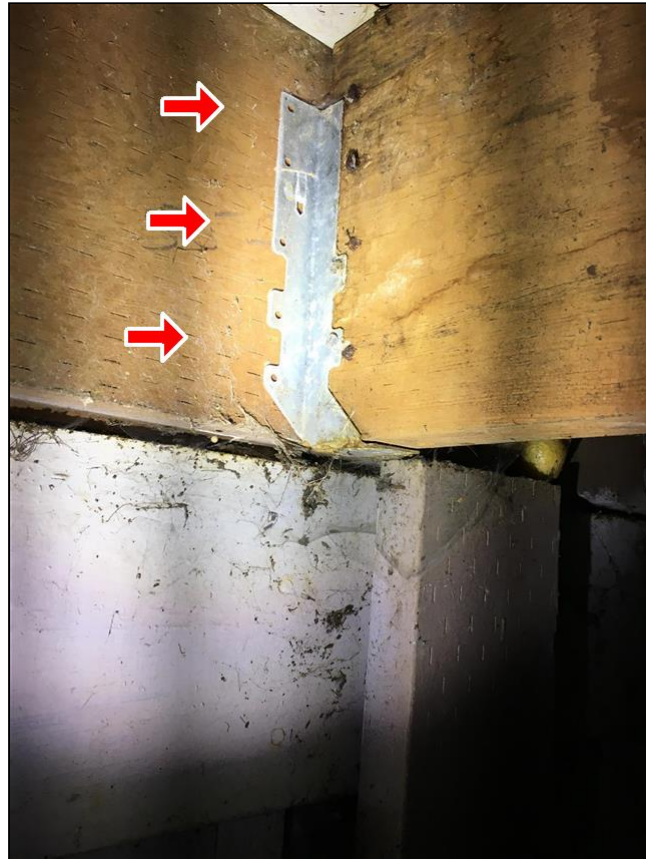
3.6 (4)

(3) The ledger board connecting the deck to the home structure was fastened nails only. Installed hangers were not properly nailed as per there required nailing pattern. Due to temperature and moisture cycles, nails will eventually loosen. While no failure was seen at the time of the inspection and this was standard practice for many years, the modern standard fastener schedule for attachment to the home structure is one half-inch lag screw installed every two feet, staggered up and down. The Inspector recommends having properly sized and spaced bolts installed by a qualified contractor.

🐿️ (3) The ledger board connecting the deck to the home structure was fastened nails only. Installed hangers were not properly nailed as per there required nailing pattern. Due to temperature and moisture cycles, nails will eventually loosen. While no failure was seen at the time of the inspection and this was standard practice for many years, the modern standard fastener schedule for attachment to the home structure is one half-inch lag screw installed every two feet, staggered up and down. The Inspector recommends having properly sized and spaced bolts installed by a qualified contractor.

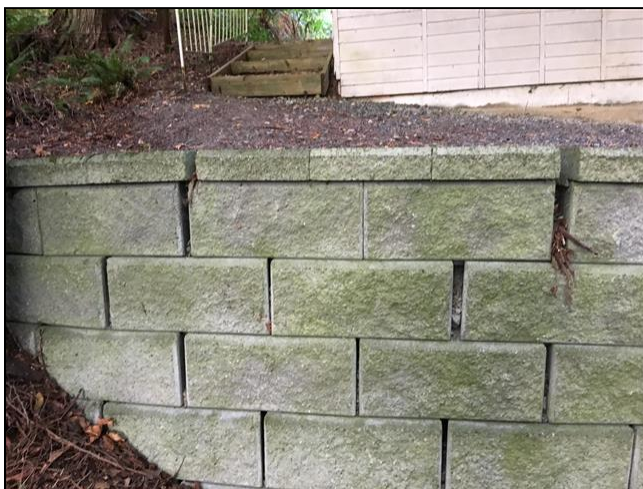
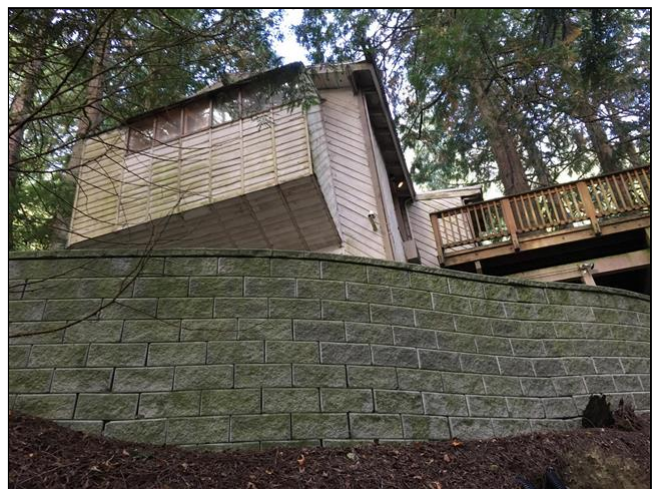
The retaining walls show signs of settlement and require repair or replacement to ensure the foundation maintains its footing. Before the expiration of your Inspection Objection Deadline you should contact a foundation repair or landscape contractor to discuss options and costs for replacement.

⚠️ The retaining walls show signs of settlement and require repair or replacement to ensure the foundation maintains its footing. Before the expiration of your Inspection Objection Deadline you should contact a foundation repair or landscape contractor to discuss options and costs for replacement.

3.7 (1) Retaining Wall Settlement

3.7 (2) Retaining Wall

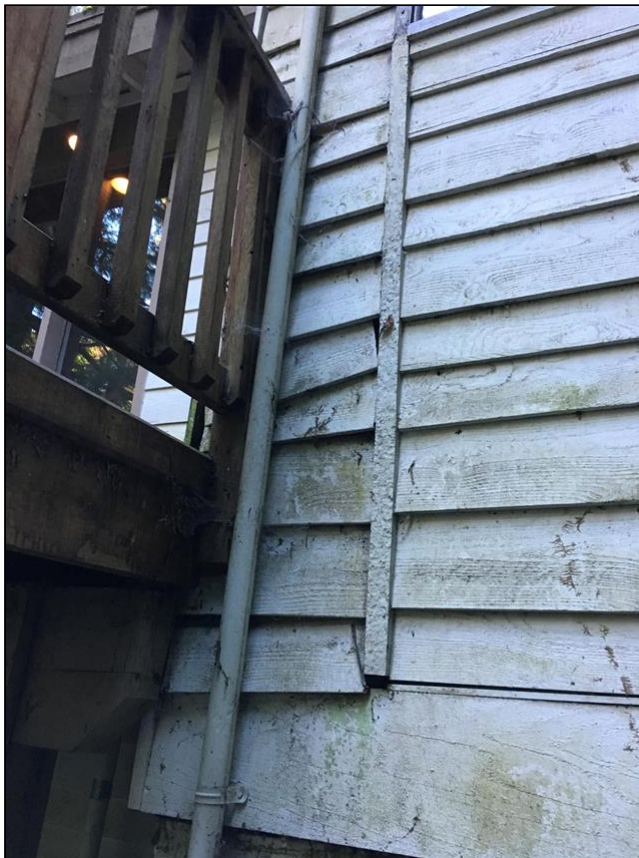
The Inspector recommends that finish coat maintenance be performed to prevent deterioration and extend the lifespan of wood siding components. All work should be performed by a qualified contractor.

4.4 (1) Cedar Siding

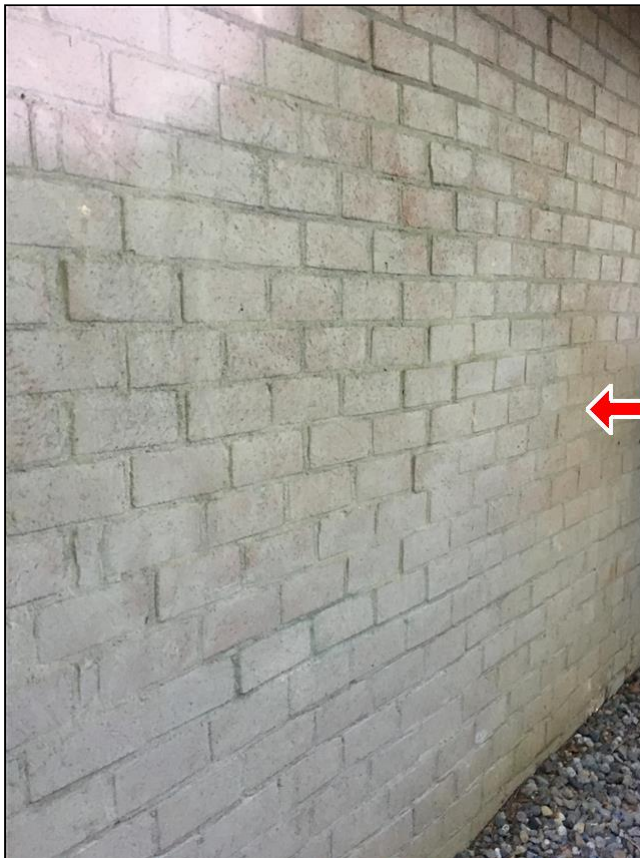
4.5 (1)

The brick exterior walls were not flat and straight but various portions bowed in and out. This may indicate that metal fasteners designed to secure the brick to the underlying substrate have failed. This is not uncommon in older homes as metal fasteners fail due to corrosion. The Inspector recommends that before the expiration of your Inspection Objection Deadline you consult with a qualified masonry contractor to gain an idea of options and costs for correction or stabilization, which may be relatively expensive.

⚠ The brick exterior walls were not flat and straight but various portions bowed in and out. This may indicate that metal fasteners designed to secure the brick to the underlying substrate have failed. This is not uncommon in older homes as metal fasteners fail due to corrosion. The Inspector recommends that before the expiration of your Inspection Objection Deadline you consult with a qualified masonry contractor to gain an idea of options and costs for correction or stabilization, which may be relatively expensive.

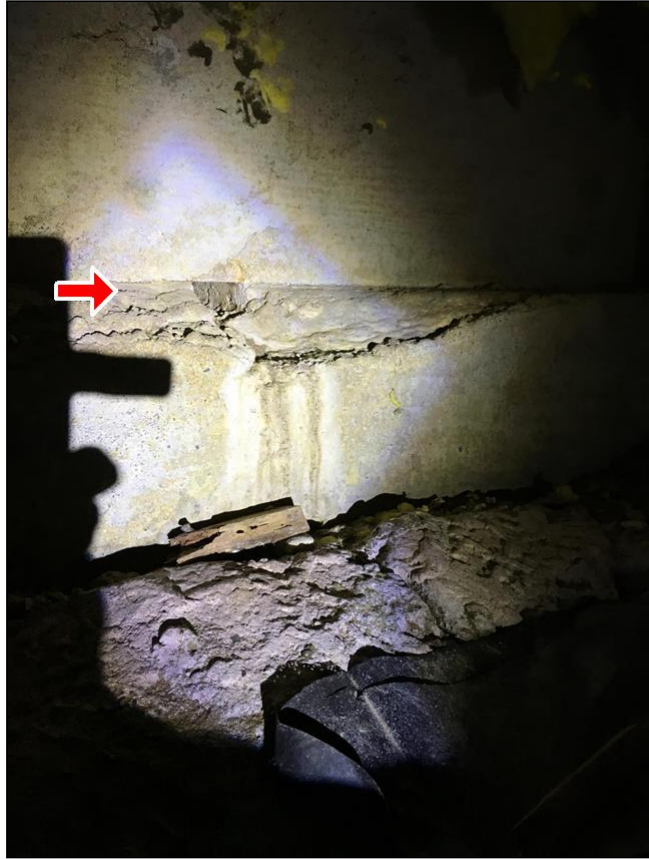
Ground water appears to be seeping in through holes in the foundation wall created by the wooden forms during the original concrete pour. This introduces unwanted moisture into the crawlspace. This holes should be sealed to prevent further water entry.

5.3 (1) Concrete Form Holes

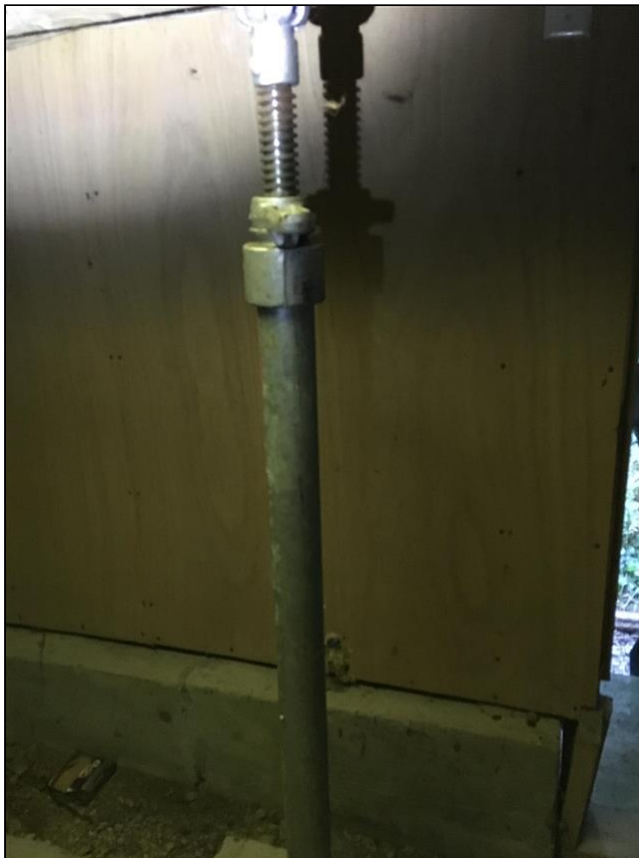
5.4 (1)

It is noted that metal jack screws have been used to supplement the support posts for the house main support girders.

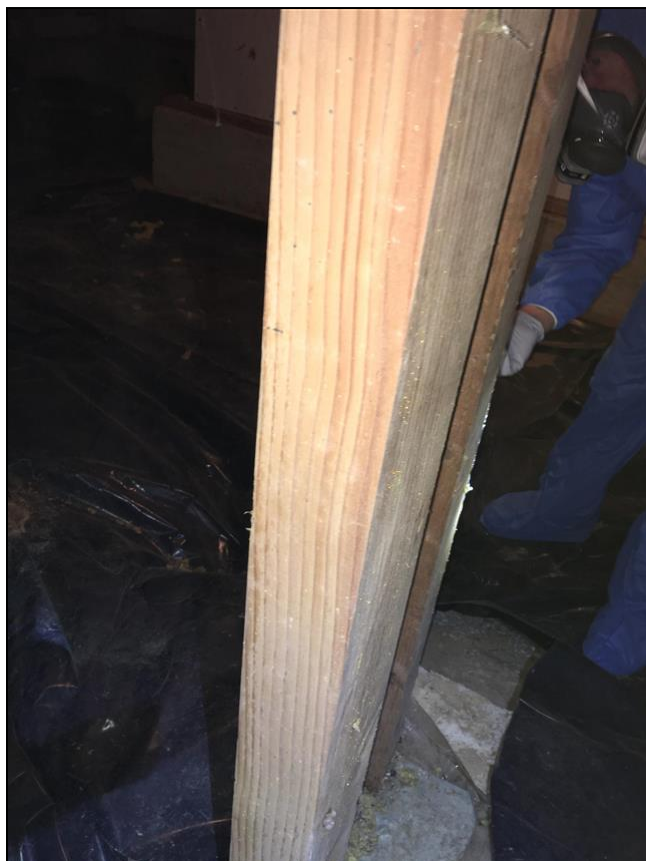
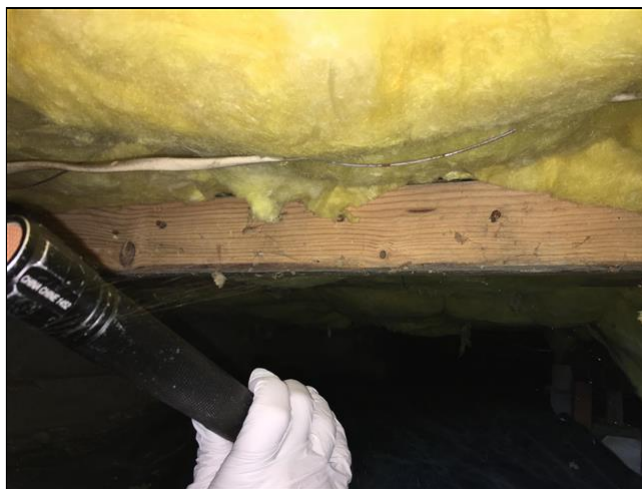
Anobiid beetle damage was noted in some of the wood in the building - see exit holes on wood: This is very common in older lumber that was often not properly kiln dried. No powdery frass was found during visual inspection indicating this is not an active problem, however, damaged wood was found that may require repair. Repair of anobiid beetle damaged framing can be complicated and subjective - there is no precise metric to determine which wood is in need of repair and which wood is not. Anobiid beetles can re-infest at any time and they tend to favor wood with a moisture content of 13-20%. Organic control of anobiids is to implement maintenance and repairs as needed to keep wood as dry as possible and to keep spaces properly ventilated. Anobiids on exterior wood can be more complicated to control. I recommend additional inspection of damaged wood by a qualified general contractor. Repair all damaged wood as recommended and implement repairs as needed to keep moisture content of wood below 13%.

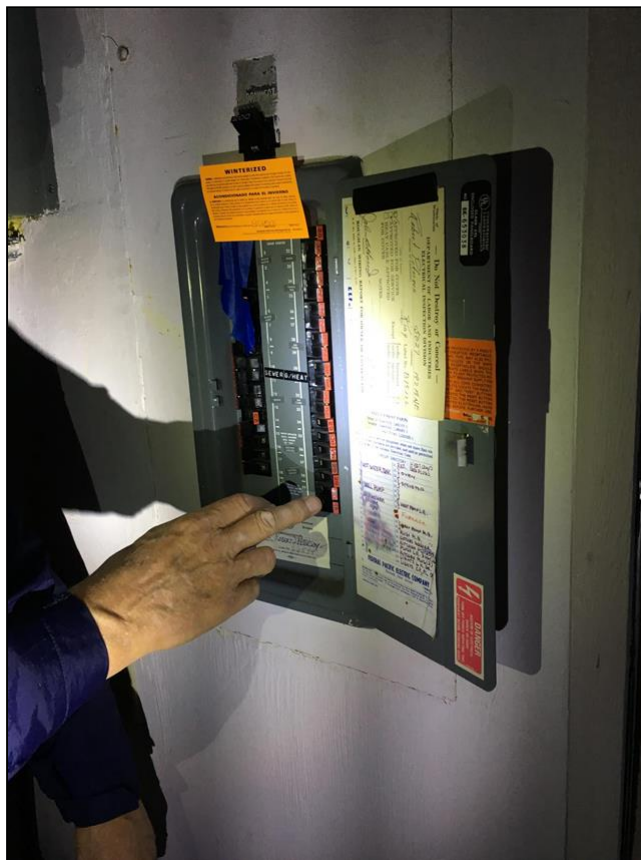
6.6 (1)

The service panel was made by Federal Pacific and was the Stab-lok model. Federal Pacific Stab-lok model service panels are reputed to have a high rate of circuit breaker failure which can result in a fire or shock/electrocution. The Inspector recommends that before the expiration of your Inspection Objection Deadline, you consult with a qualified

electrical contractor concerning the necessity for replacing this service panel. Information about defective Federal Pacific Stab-lok panels is widely available on the internet.

⚠ The service panel was made by Federal Pacific and was the Stab-lok model. Federal Pacific Stab-lok model service panels are reputed to have a high rate of circuit breaker failure which can result in a fire or shock/electrocution. The Inspector recommends that before the expiration of your Inspection Objection Deadline, you consult with a qualified electrical contractor concerning the necessity for replacing this service panel. Information about defective Federal Pacific Stab-lok panels is widely available on the internet.

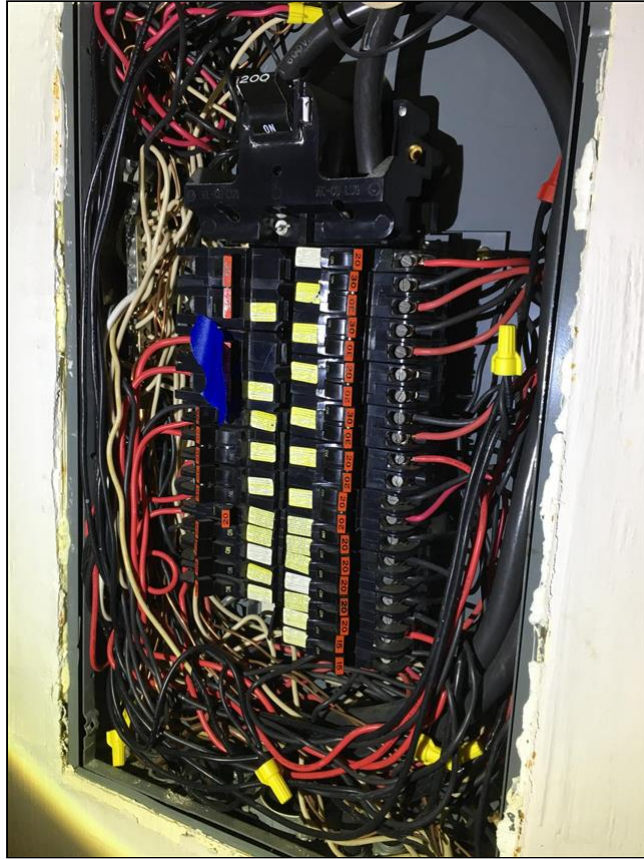
6.9 (1)

The service panel was overly filled with wiring. Generally-accepted current standards require that not more than 75% of the cross-sectional area of the main panel space be filled. The Inspector recommends correction by a qualified electrical contractor.

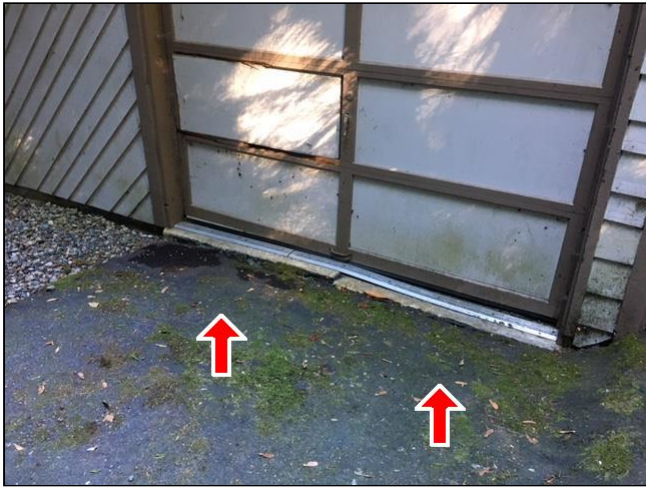
(2) The garage vehicle door has cracked panels. The Inspector recommends repair by a qualified contractor. Additionally, the garage door and lower threshold are damaged. Recommend repair by a qualified contractor.

7.0 (1) Garage Door Damage

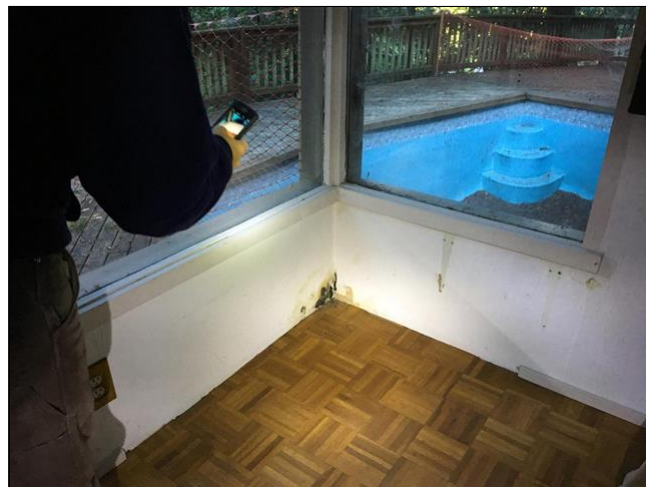
Stains on the walls in the 1st main floor bedroom 2nd main floor bedroom visible at the time of the inspection appeared to be the result of moisture intrusion. The moisture meter showed elevated moisture levels in the affected areas at the time of the inspection, indicating that the leakage has been recent. The Inspector recommends consultation with a qualified contractor to discuss options and costs for correction and repair.

8.1 (1) Water Damage

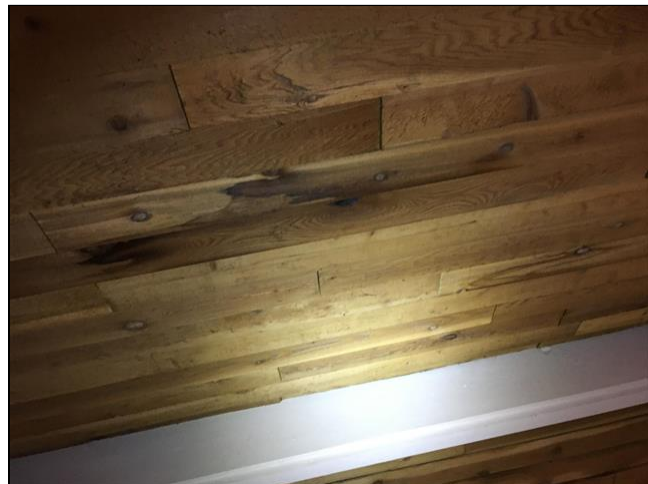
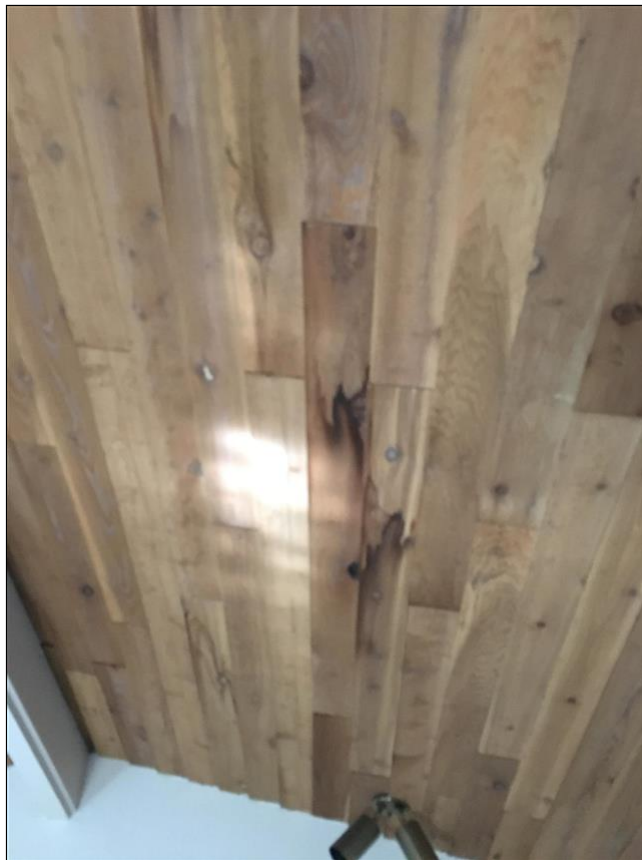
Ceiling damage visible in the the master bathroom appeared to be from moisture, possibly from roof leakage. The source of moisture should be identified and corrected to avoid continuing damage.

8.2 (1) Roof Leak

8.2 (2) 2nd Roof Leak

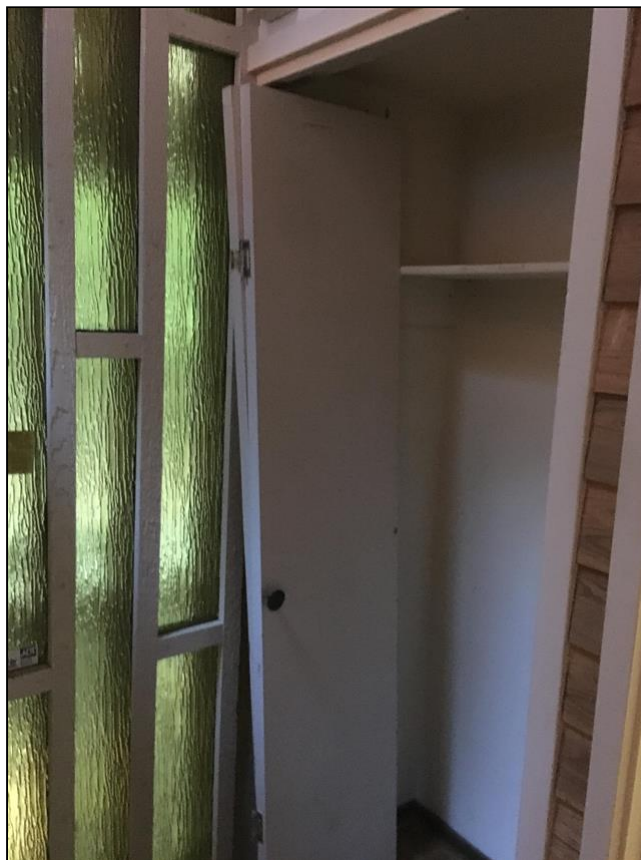
8.5 (1)

Closet doors in the hallway closet needed adjustment at the time of the inspection. The Inspector recommends service by a qualified contractor.

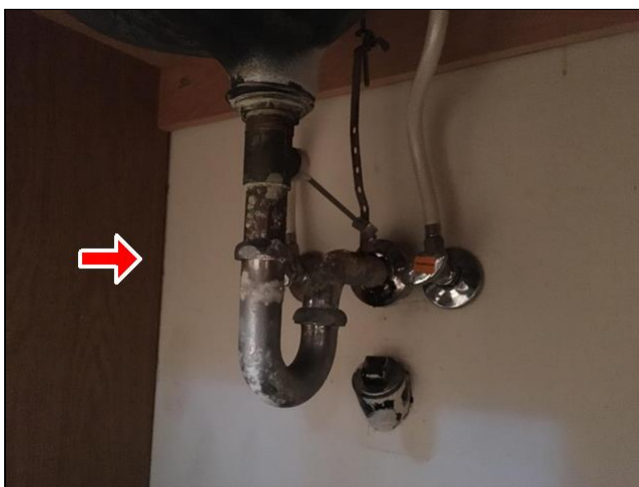
9.4 (1)

(2) The drain lines under the master bathroom sink show signs of corrosion, the extent of which is hard to determine. Recommend replacement by licensed plumber.

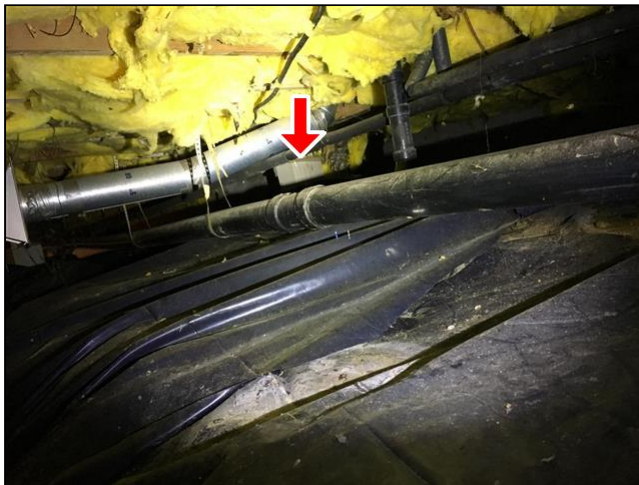
9.4 (2)

(3) The waste plumbing is not properly sloped to drain. There is a pronounced dip in the main discharge line which can cause accumulation of solids and reduced drainage. One quarter inch / foot slope needs to be maintained in the direction of the sewer. Hire a licensed plumber to further evaluate and repair the sewer line and adjust the support as needed.

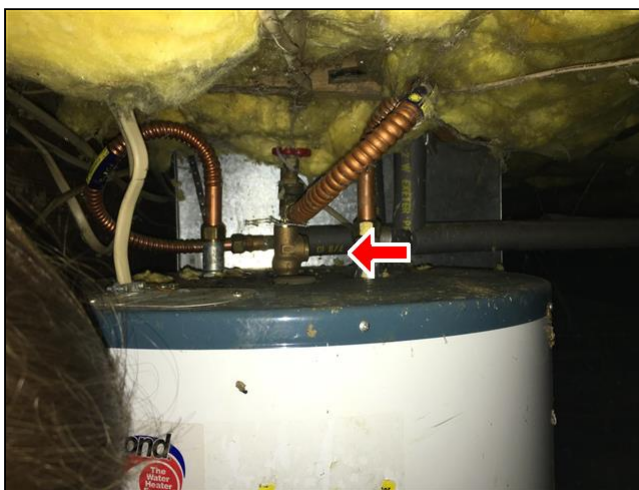
9.5 (1)

(1) The temperature/pressure relief (TPR) valve discharge piping is not present. This directs scalding water towards the ground in the event that the valve is activated. Recommend the discharge piping be installed by a licensed plumber.

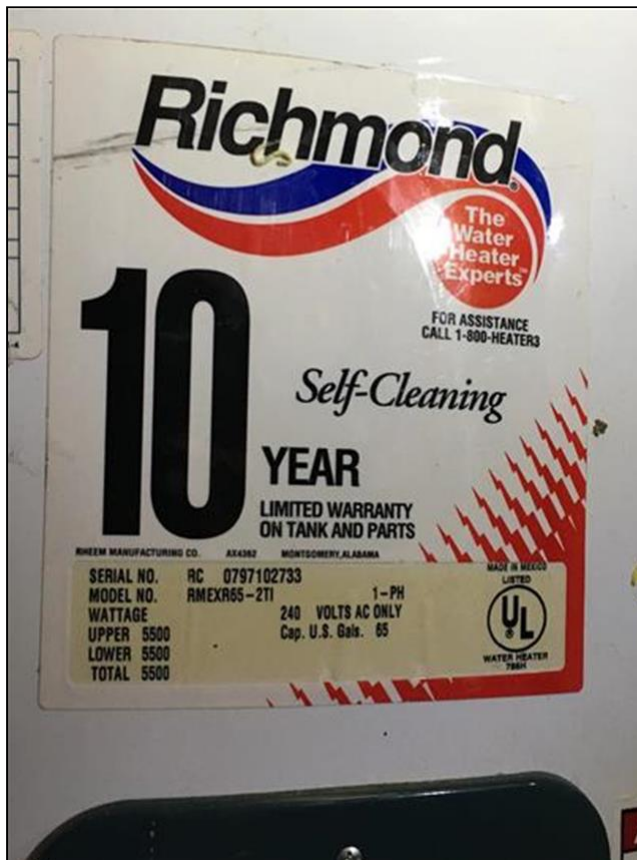
9.5 (2)

(2) This hot water heater was manufactured in 1997. This water heater appeared to be past its design life and may need replacement soon.

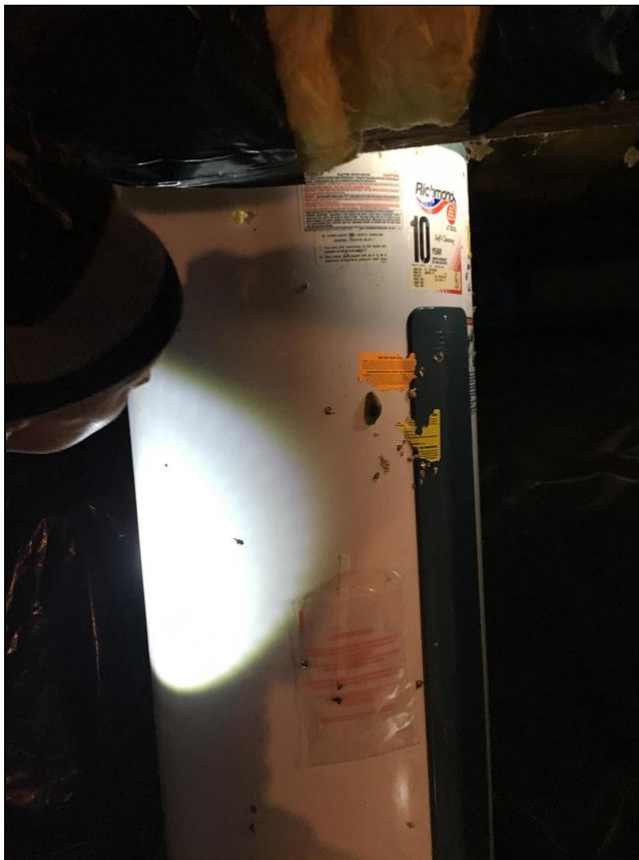
9.5 (3)

(4) This water heater was not fastened securely. Because the home is located in an area subject to seismic activity, modern safety standards require water heaters in this building jurisdiction to be secured with straps. The Inspector recommends correction by a qualified contractor.

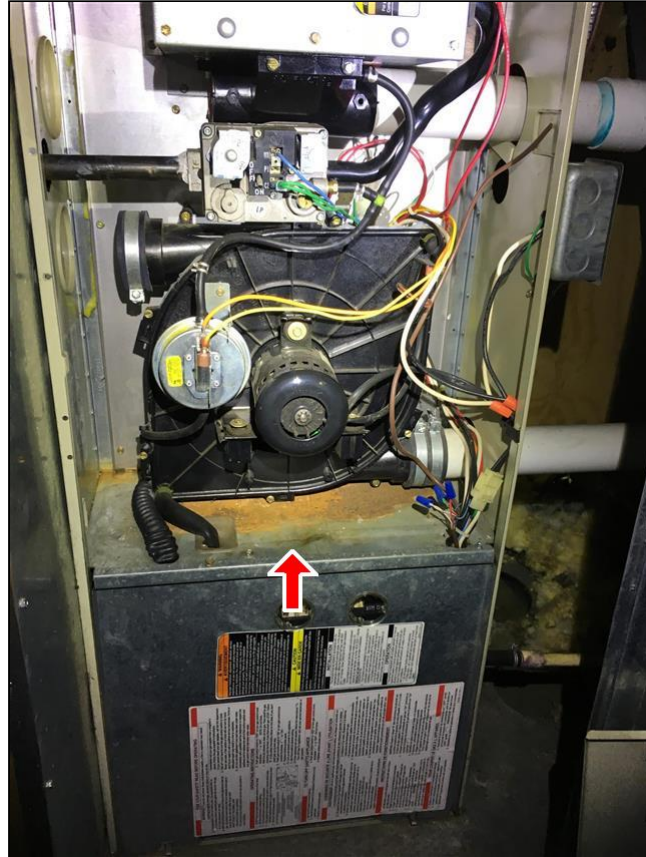
10.1 (1)

The furnace cabinet interior had excessive corrosion visible in areas. This condition appeared to be related to condensation, indicating possible improper exhaust venting or combustion. Improper exhaust venting or combustion can result in the introduction of unacceptably high levels of toxic gases such as carbon monoxide into the living space. The Inspector recommends service by a qualified HVAC technician to ensure safe and efficient operating conditions exist.

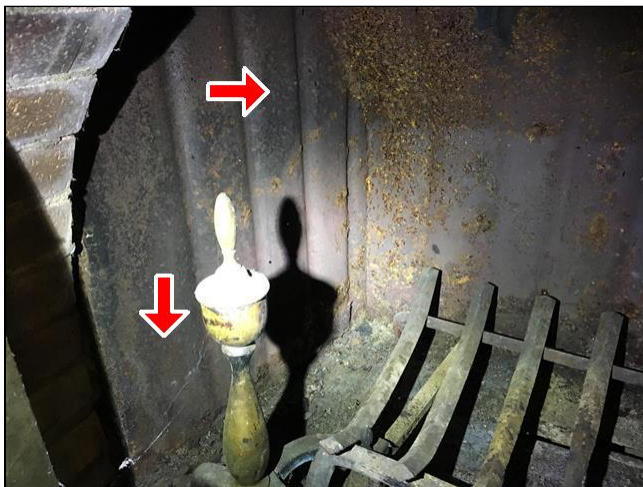
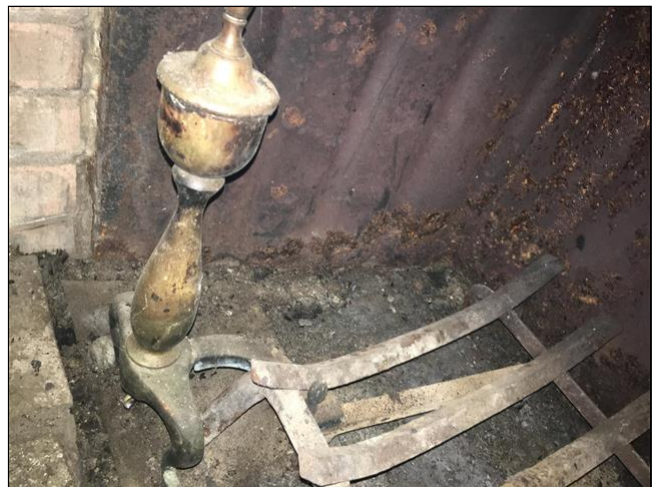
(1) There is considerable corrosion in the firebox indicating signs of high moisture due to possible chimney leakage previously noted in the report.

10.5 (1) Firebox corrosion
