Inspection Report for Mr. Jason Smith

Property Address: 124 13rd St NE, Seattle, Washington 98052

NW WASHINGTON HOME INSPECTIONS LLC

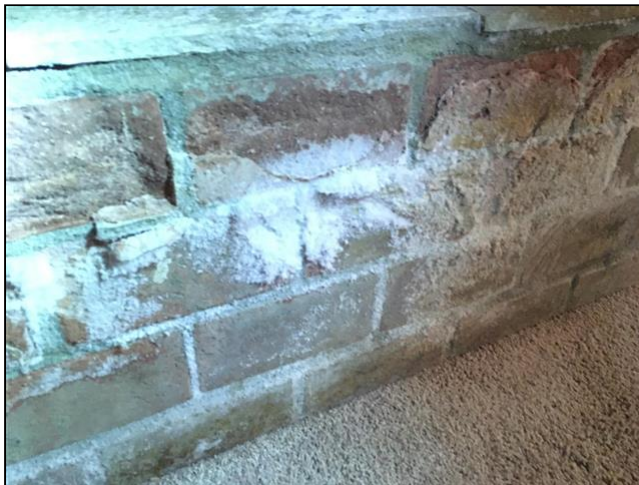
10.5 (3)

(2) Considerable efflorescence was noted on the hearth below the fireplace, further indication of a chimney moisture problem.

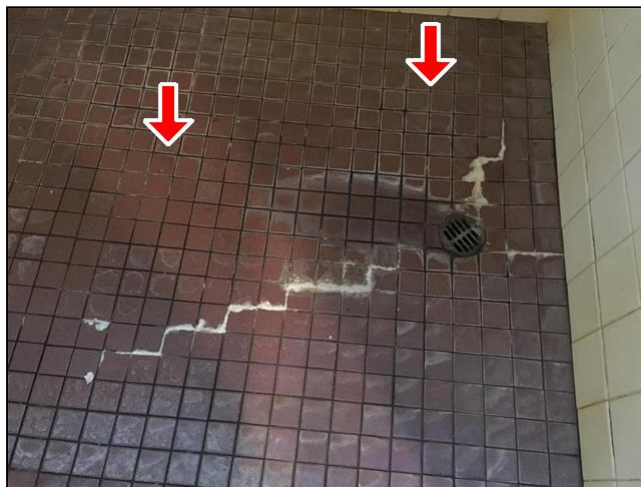
11.11 (1)

In the master bathroom, the moisture meter indicated moisture intrusion beneath the floor tiles. Typical water entry points are where grout lines have failed. The Inspector recommends that points of water entry be identified and corrected to avoid potential damage to the floor structure from decay.

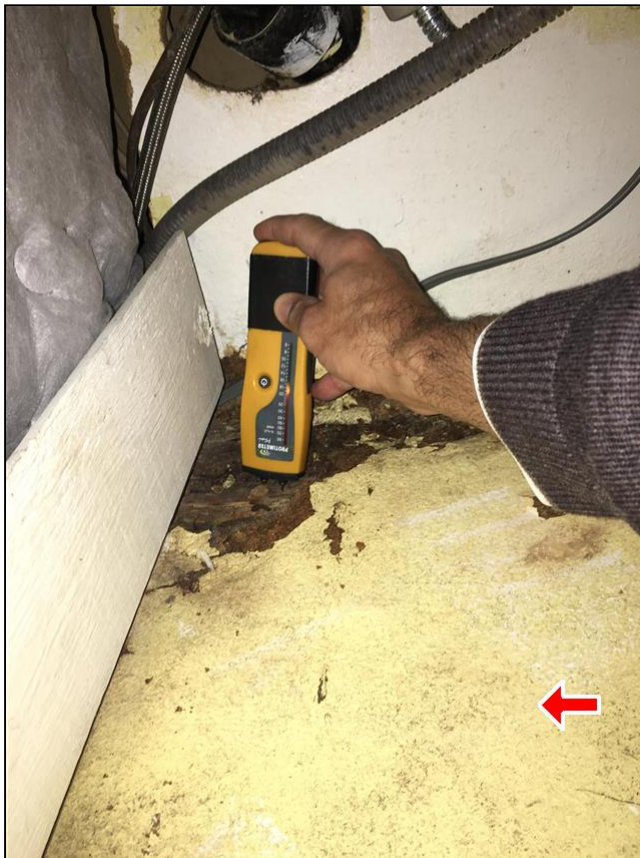
12.9 (1)

(1) The kitchen cabinets below the sink had moderate moisture damage below the kitchen sink. The source of the leak could not be readily be identified. Recommend a licensed contractor repair or replace the cabinets and further identify and correct the source of the leak.

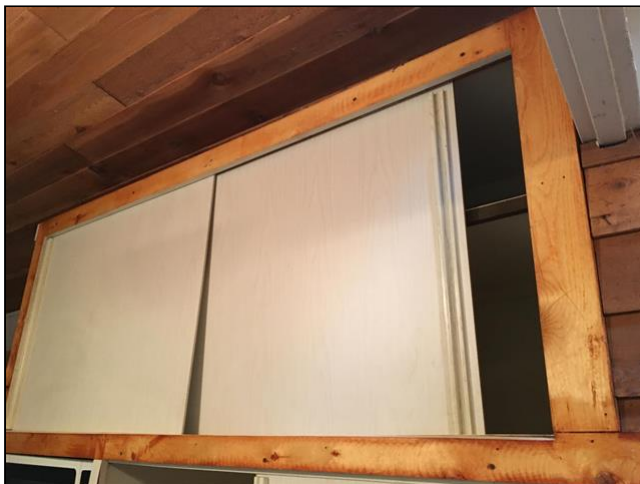
(2) Overhead kitchen cabinets require adjustment.

12.9 (2) Overhead Cabinets

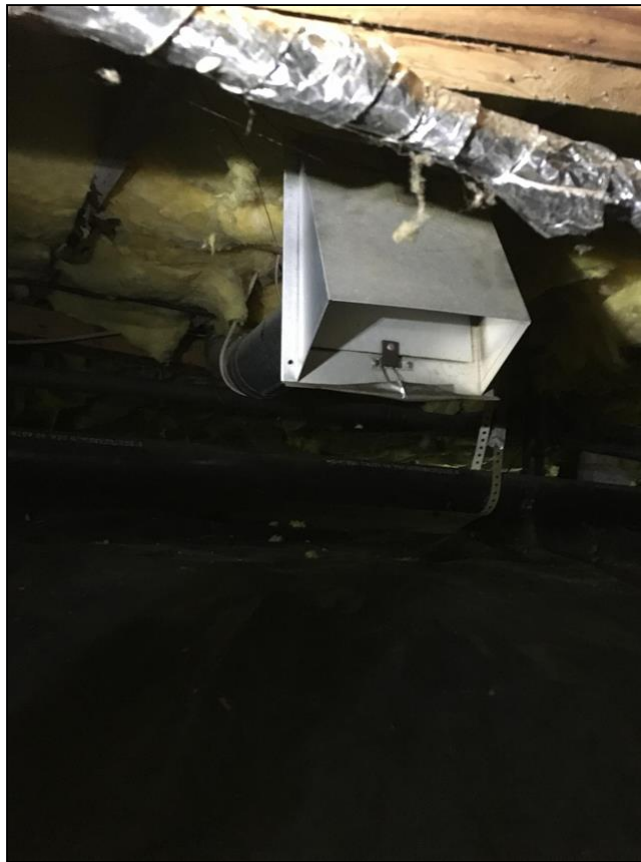
The kitchen down-draft vent discharges into the crawlspace which can contribute to higher moisture levels in the crawlspace. Recommend redirecting to vent to the exterior of the house.

12.13 (1) Venting to Crawlspace

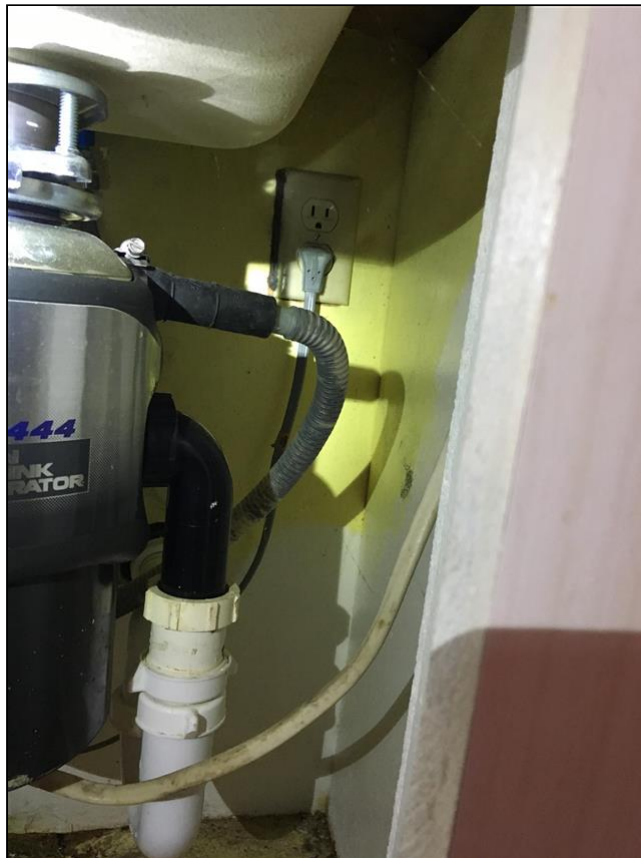
12.14 (1)

The dishwasher did not appear to have an anti-siphon device installed in the drain line. Anti-siphon devices are installed to prevent wastewater from the dishwasher from being siphoned back into the dishwasher and contaminating its contents. The Inspector recommends an anti-siphon device be installed by a qualified technician.

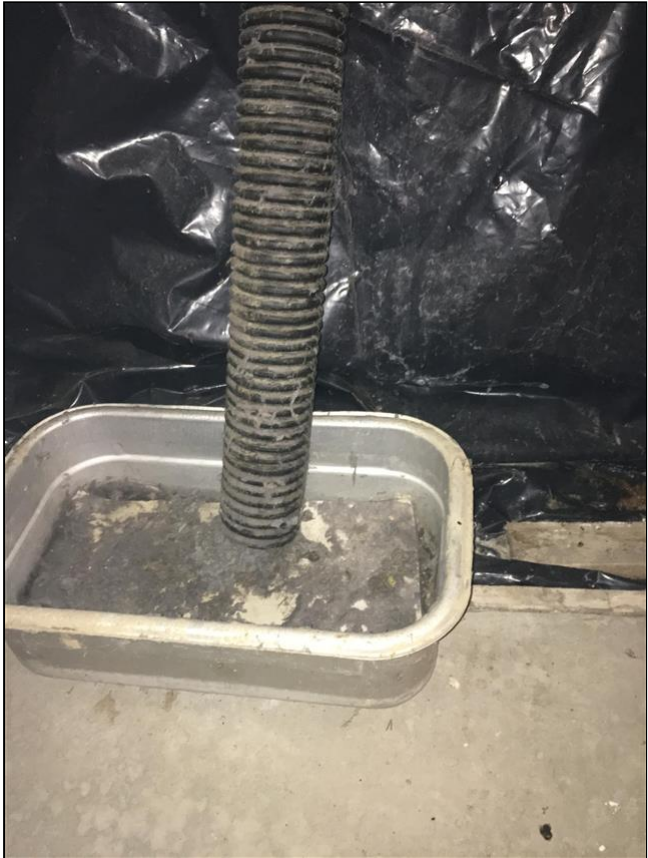
The dryer was vented using a flexible, ribbed plastic vent that is not approved by the Underwriter's Laboratory (UL). This type of dryer exhaust vent is more likely to accumulate lint than a smooth metal vent, creating a potential fire hazard. Excessive lint accumulation can also increase drying time and shorten the dryer's lifespan. The Inspector recommends replacing this plastic vent with a properly-installed, UL-approved dryer vent. All work should be performed by a qualified contractor.

13.3 (1) Dryer Vent into Crawlspace
