Inspection Report for Mr. Jason Smith

Property Address: 124 13rd St NE, Seattle, Washington 98052

NW WASHINGTON HOME INSPECTIONS LLC

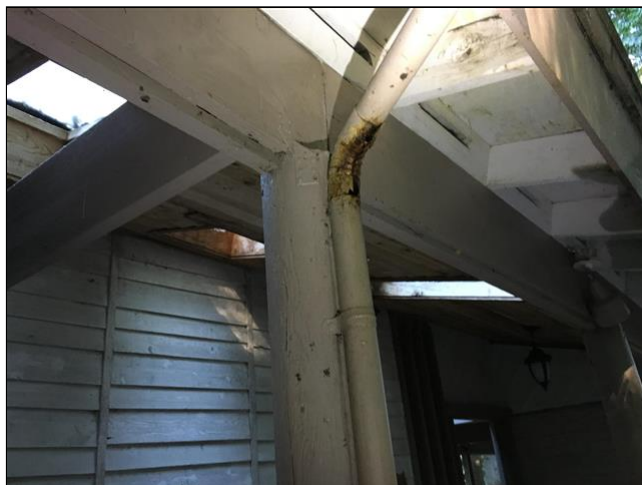
1.3 (2) Failing Gutters

The rotting wood represents conditions conducive to wood destroying organism. Removal and replacement of the failed gutters will eliminate the risk.

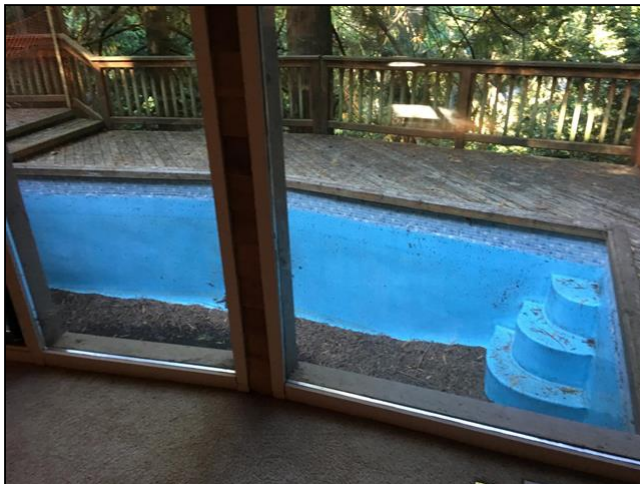
3.9 (1) Pool

The home has a pool attached to the back of the house. This is outside the scope of this inspection.

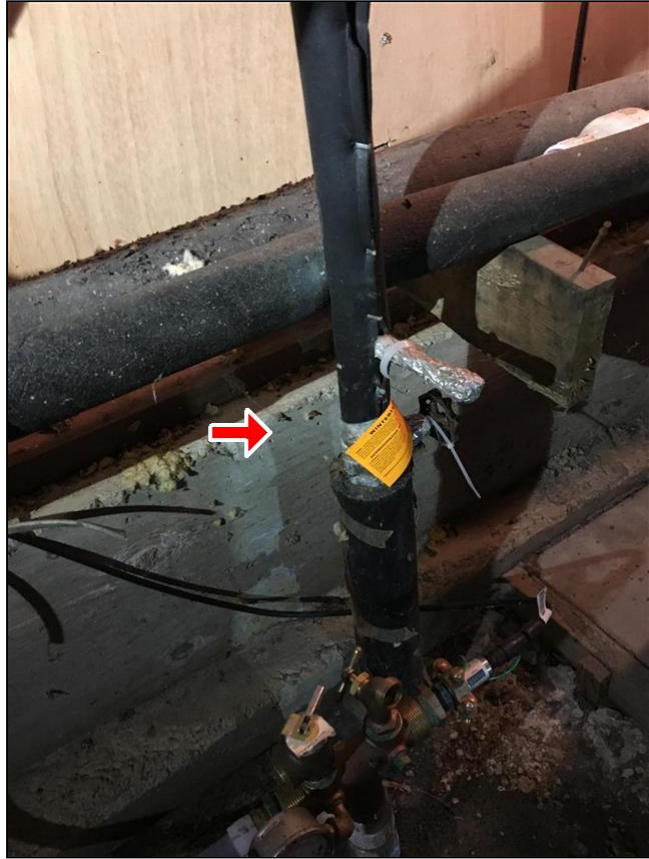
9.1 (1) Main Water Cutoff in Crawl Space

The home water was supplied from a private well located on the property. The main water cutoff valve is located in the crawl space.

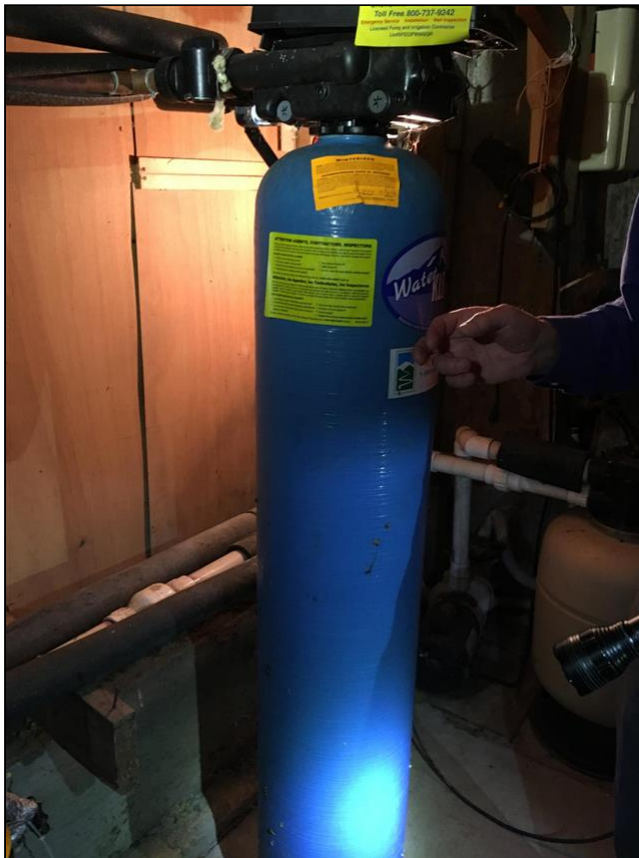
9.3 (1)

The home contained a whole-house water filtration system. You should contact the manufacturer to find out what maintenance is required.

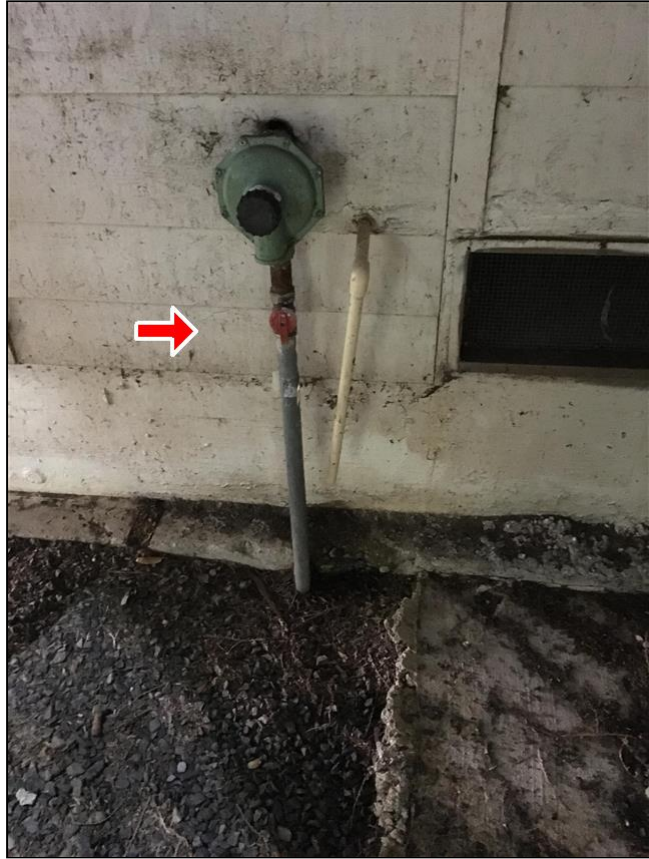
10.2 (1)

The propane shut off valve is located under the deck on the back of the house.

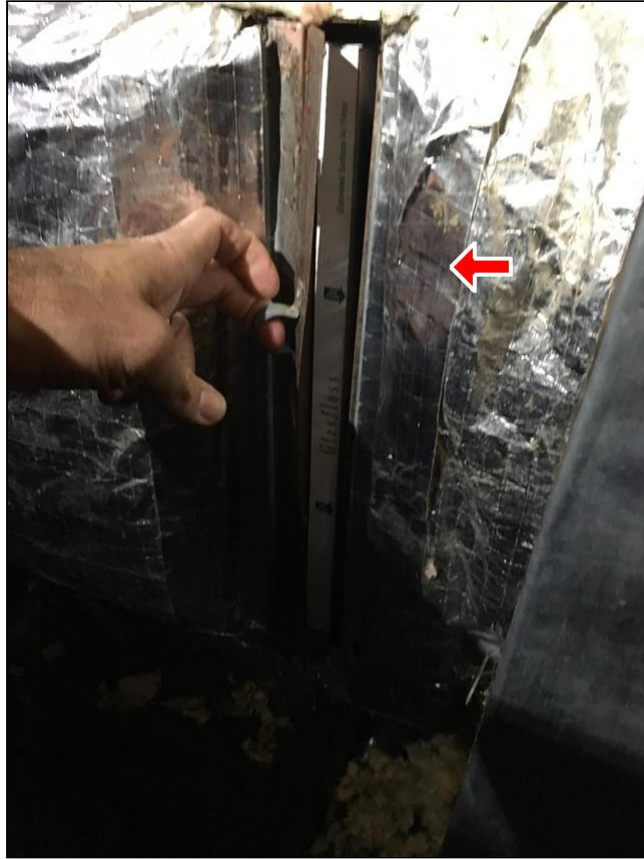
10.4 (1)

The air filter for this furnace appeared to be in serviceable condition at the time of the inspection. Filters should be checked every three months and replaced when they reach a condition in which accumulation of particles becomes so thick that particles may be blown loose from the filter and into indoor air. Homes in areas with high indoor levels of airborne pollen or dust may need to have air filters checked and changed more frequently. Failure to change the filter when needed may result in the following problems: - Reduced blower life due to dirt build-up on vanes, which increasing operating costs. - Reduced effectiveness of air filtration resulting in deterioration of indoor air quality. - Increased resistance resulting in the filter being sucked into the blower. This condition can be a potential fire hazard. - Frost build-up on air-conditioner evaporator coils, resulting in reduced cooling efficiency and possible damage. - Reduced air flow through the home.
